Enhanced Preliminary Assessment Report:

Herminie Army Housing Units
Herminie, Pennsylvania

October 1989

Environmental Research Division
Argonne National Laboratory
Argonne, Illinois 60439

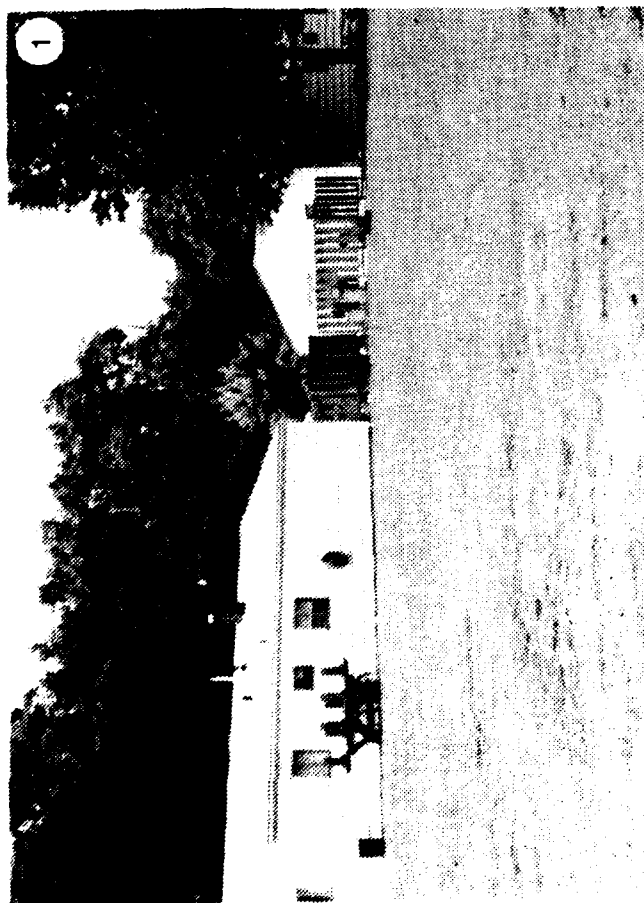
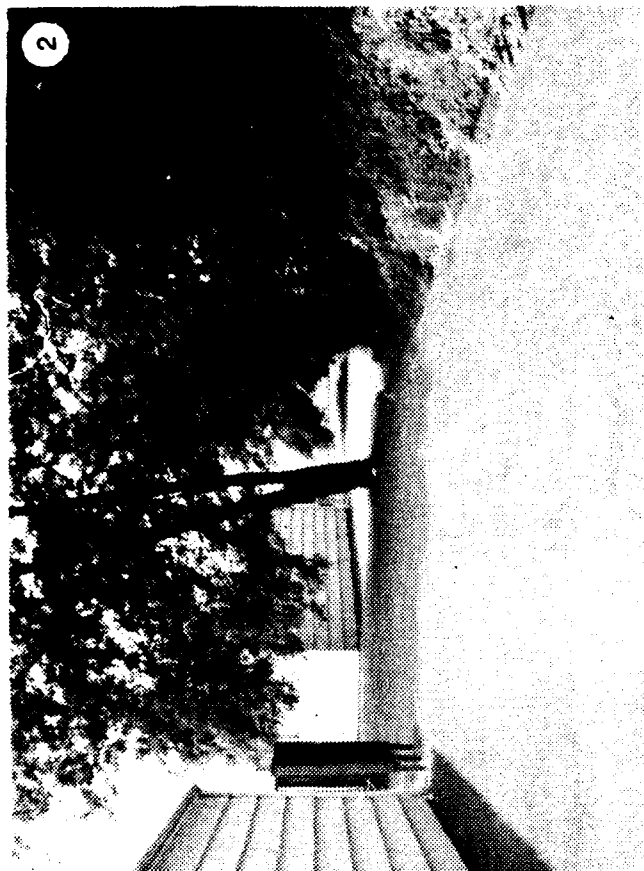
IDENTIFICATIONS OF PHOTOGRAPHS

1. The rear of two units at the housing area.
2. An open drain for storm water runoff at the junction of the lawn area and the sloping ground.
3. Playground at the housing area.
4. Electrical transformer at the top of the utility pole; transformers are the property of the U.S. government.
5. The sewage-treatment system, behind the fence, is a trickle rock-bed design that provides for chlorination of the wastewater before it is released.
